## **Central California Conference of Seventh-Day Adventists**

**West Valley S.D.A. Elementary School**

**US EPA AHERA Re-Inspection Report  
February 2017**

**February 13, 2017**

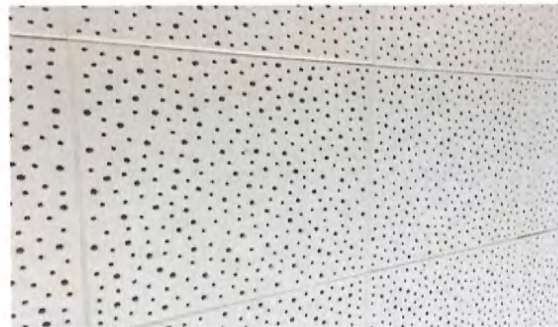
Material: ACT and Mastic - 12" Random Hole  
HMR #: 4  
Asb:  
Comment:

<b>Ceiling:</b>	ACT and Mastic - 12" Random Hole	MISC	Assumed	4	468 sq	No
	<i>Comment: Material is DAMAGED.</i> <i>Comment: Material has several spots of impact from what appears to be a hammer face or possibly end of a mop handle.</i> <i>These tiles are physically damaged, but not in a friable condition.</i>					
<b>Ceiling:</b>	Drywall - Medium Texture	MISC	Assumed	3	468 sq	No
	<i>Comment: Material in GOOD condition.</i> <i>No change in material condition.</i> <i>Above the ACTs in the space.</i>					
<b>Room Comments:</b>	L shaped through lower floor of building					
<b>Building:</b> 01 - Main Building		<b>Room:</b> 02 - Main Office - 24 x 18 x 8				
<b>Floor:</b>	9" VFT and Mastic - Tan with Speck	MISC	Assumed	1	432 sq	No
	<i>Comment: Material in GOOD condition.</i> <i>No change in material condition.</i> <i>Material is below the carpet of the space.</i>					
<b>Floor:</b>	Carpet and Mastic - Brown Multi	MISC	Assumed	22	432 sq	No

<b>Ceiling:</b> ACT and Mastic - 12" Random Hole	MISC	Assumed	4		450 sq	No
<i>Comment: Material is DAMAGED. Comment: There are a number of tiles that have fallen off the ceiling in the space near the stairs leading to ground level. There are a number of tiles that have fallen off the ceiling in the space near the stairs leading to ground level.</i>						
<b>Ceiling:</b> Drywall - Medium Texture	MISC	Assumed	3		492 sq	No
<i>Comment: Material in GOOD condition. No change in material condition. Above the ACTs and at stairwell of the space.</i>						
<b>Removed Materials:</b>						
<b>Baseboard:</b> Wood 2"	NON	Non-Suspect				
<i>Comment: Material has been REMOVED.</i>

<i>Comment: Material in GOOD condition. No change in material condition.</i>					
<b>Ceiling:</b>	ACT and Mastic - 12" Random Hole	MISC	Assumed	4	1944 sq	No
	<i>Comment: Material is DAMAGED. Comment: There are five tiles missing from the ceiling finish, but remnants of the mastic pucks remain. There are five tiles missing from the ceiling finish, but remnants of the mastic pucks remain.</i>					
<b>Ceiling:</b>	Drywall - Medium Texture	MISC	Assumed	3	1944 sq	No
	<i>Comment: Material in GOOD condition. No change in material condition. Above the ACTs in the space.</i>					
<b>Removed Materials:</b>						
<b>Baseboard:</b>	2" Baseboard and Mastic - Brown	MISC	Assumed	2	180 in	No
	<i>Comment: Material in GOOD condition. Material has been REMOVED. Not able to determine if material was ever present or if removed since the last inspection of the site.</i>

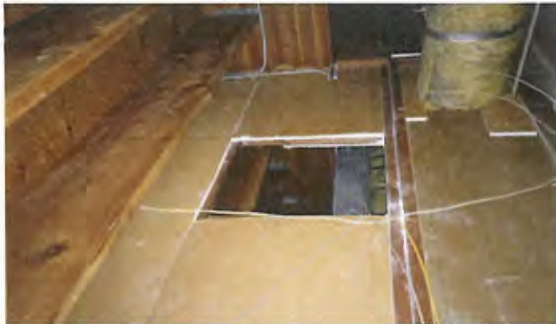
Material: Drywall - Bare  
HMR #: 26  
Asb:  
Comment: No joint compound or texture coat material associated with this drywall system.
