Hazard Management Services, Inc.

Central California Conference of Seventh-Day Adventist

Peninsula Adventist School

**US EPA AHERA Re-Inspection
March 2017**

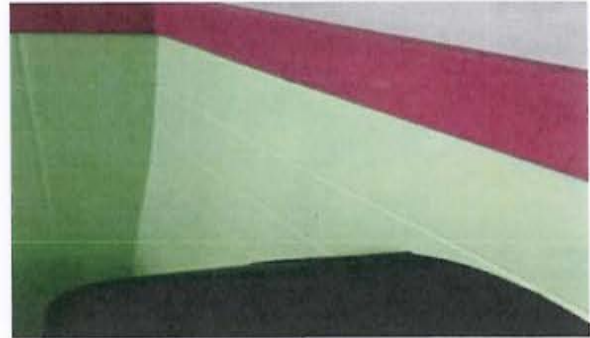
Material: FRP - Green Squares
HMR #: 6
Asb:
Comment:

1	03 - Office Building	6 MISC	FRP - Green Squares	NOT SAMPLED	03 - Restroom - Walls	Assumed	104 Square	No	Material in GOOD condition. No change in material condition.

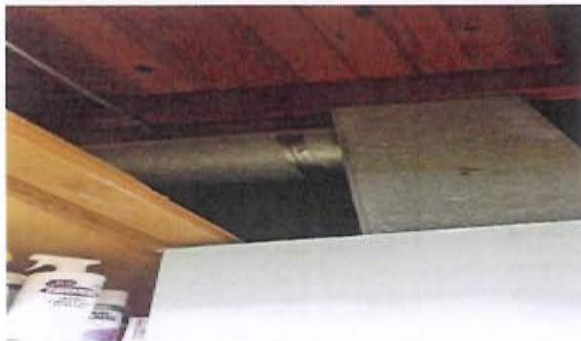
Material: Transite Flue Pipe
HMR #: 28
Asb:
Comment:

Walls: Wood	NON	Non-Suspect				
Ceiling: Wood	NON	Non-Suspect				
Pipes: Transite Flue Pipe <i>Comment: Material in GOOD condition. No change in material condition. Visible at access to attic from Office 2.</i>	MISC	Assumed	28		4 ln	No

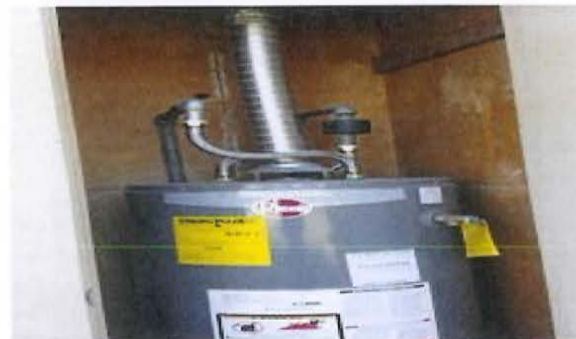
Ceiling:	Drywall - Bare	MISC	Assumed	32		9 sq	No
	<i>Comment: Material in GOOD condition. No change in material condition. Material Comment: Material does not include a skim coat or joint compound layer.</i>						
Room Comments:	A newer water heater is in this space. A key to the door could not be provided, but is accessible as door is installed backwards.

Material: Drywall - Bare
HMR #: 32
Asb:
Comment: Material does not include a skim coat or joint compound layer.
