Central California Conference of Seventh-Day Adventist

Oakhurst Seventh-Day Adventist School

US EPA AHERA Re-Inspection February 2017

HMS Project Number: F140310

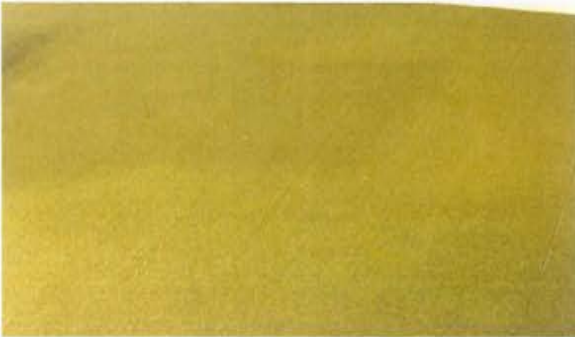
Material: Carpet, green
HMR #: 1
Asb: Assumed
Comment: Glue is assumed to contain asbestos

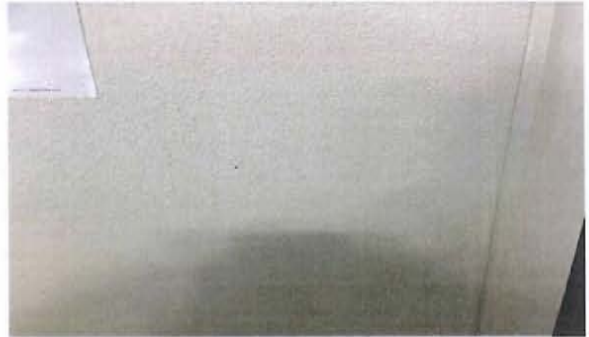
Material: FRP & glue
HMR #: 2
Asb: Assumed
Comment: Glue is suspect to contain asbestos.

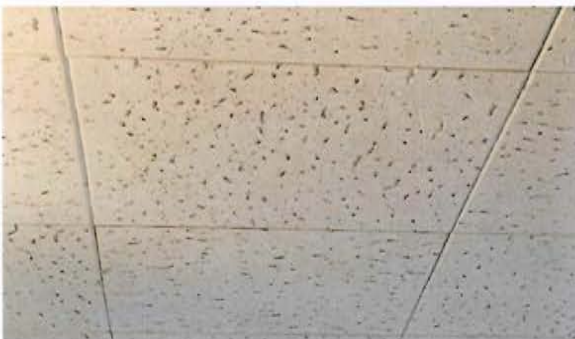
Material: Acoustic ceiling tile, 1x1
HMR #: 3
Asb: 0
Comment:

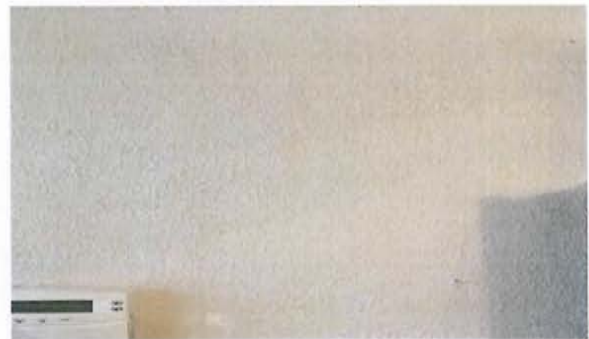
Material: Drywall, sponge texture
HMR #: 4
Asb: Assumed
Comment:

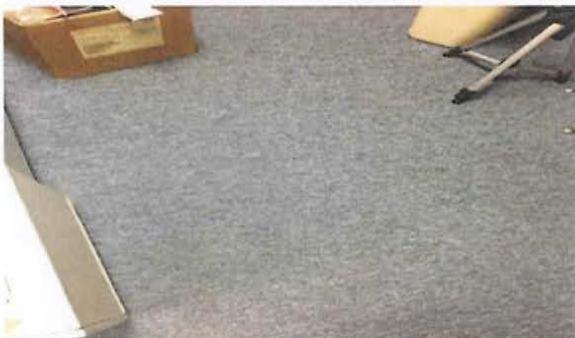
Material: Carpet 2, grey
HMR #: 5
Asb: Assumed
Comment:

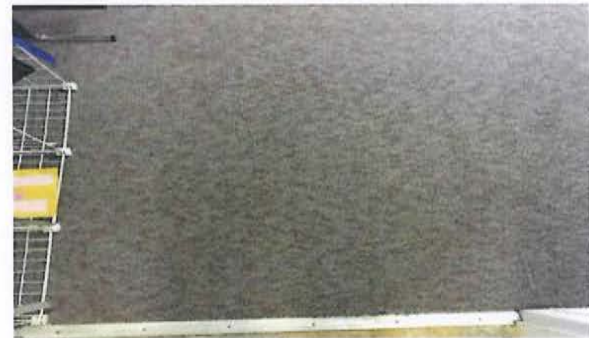
Material: Carpet 3, maroon
HMR #: 6
Asb: Assumed
Comment:

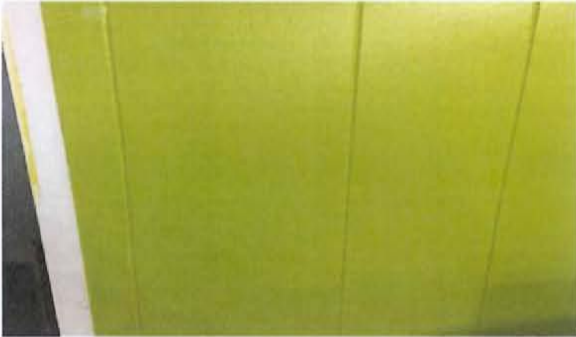
Material: Wood panel & glue
HMR #: 7
Asb: Assumed
Comment: Glue is assumed to contain asbestos

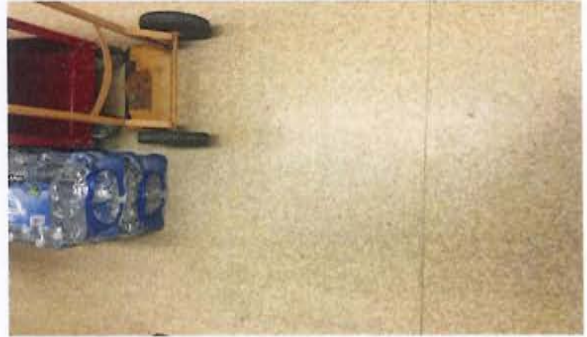
Material: Vinyl floor covering
HMR #: 8
Asb: Assumed
Comment:

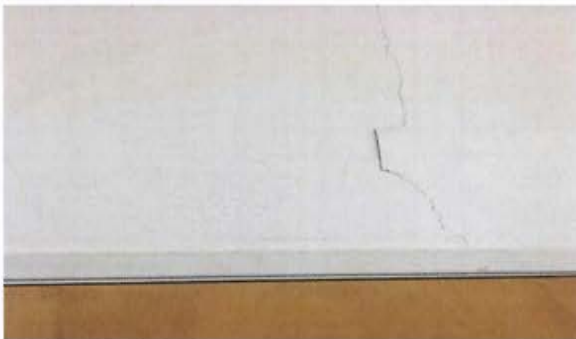
Material: Drywall 2, knockdown texture
HMR #: 9
Asb: Assumed
Comment:

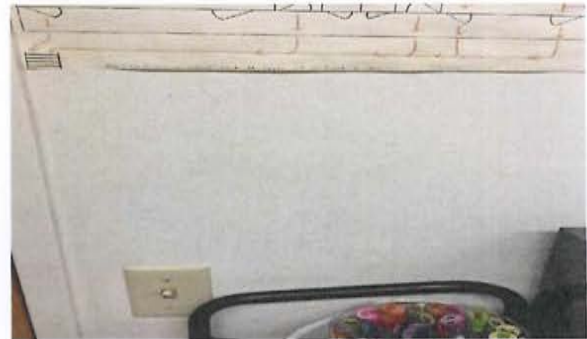
Material: Tackboard & glue
HMR #: 10
Asb: Assumed
Comment:

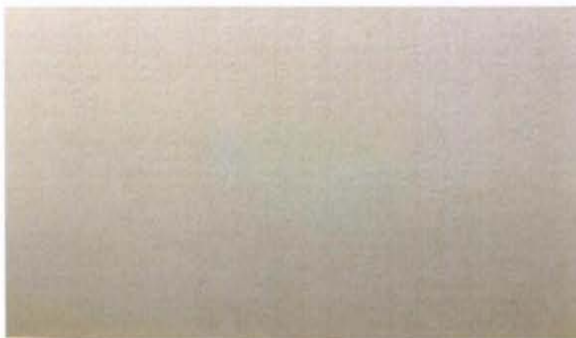
Material: Drywall 3, smooth
HMR #: 11
Asb: Assumed
Comment:

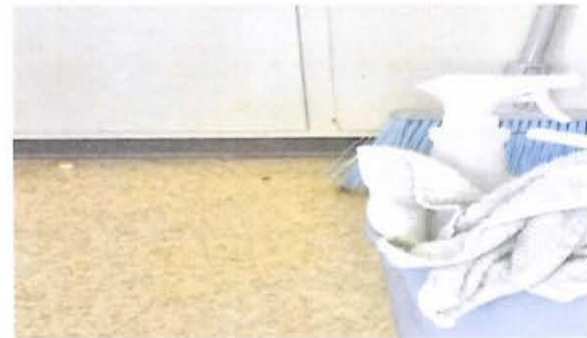
Material: Baseboard, 4" brown vinyl
HMR #: 12
Asb: Assumed
Comment:

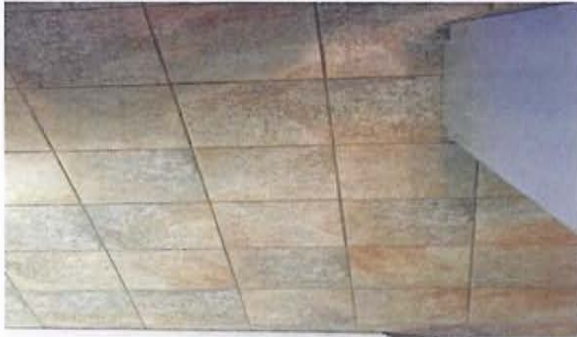
Material: 12" Vinyl Floor Tile (Brown)
HMR #: 13
Asb: Assumed
Comment:

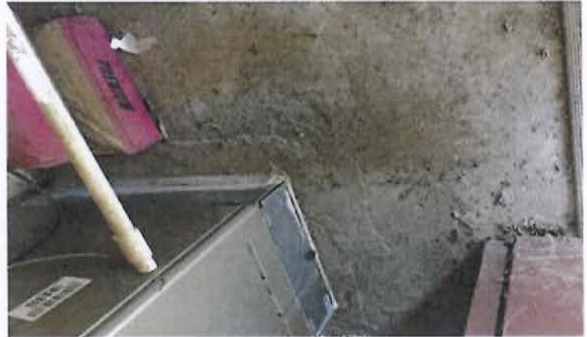
Material: Duct Mastic
HMR #: 14
Asb: Assumed
Comment:

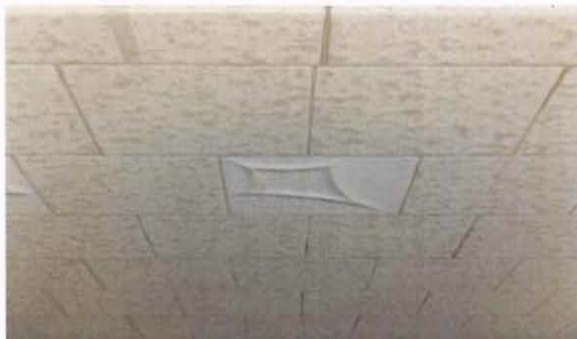
Material: Ceramic tile 3, 4" inch off-white
HMR #: 16
Asb: Assumed
Comment: The mortar / grout associated with system is suspect.

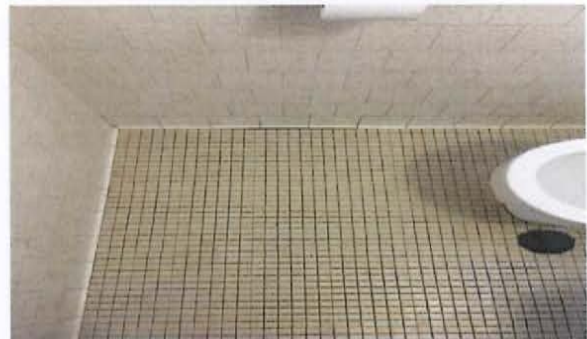
Material: Ceramic tile 2, 1" white
HMR #: 18
Asb: Assumed
Comment: The mortar / grout associated with system is suspect.
