Central California Conference of Seventh-Day Adventist

Oakhurst Seventh-Day Adventist School

US EPA AHERA Re-Inspection February 2017

HMS Project Number: F140310

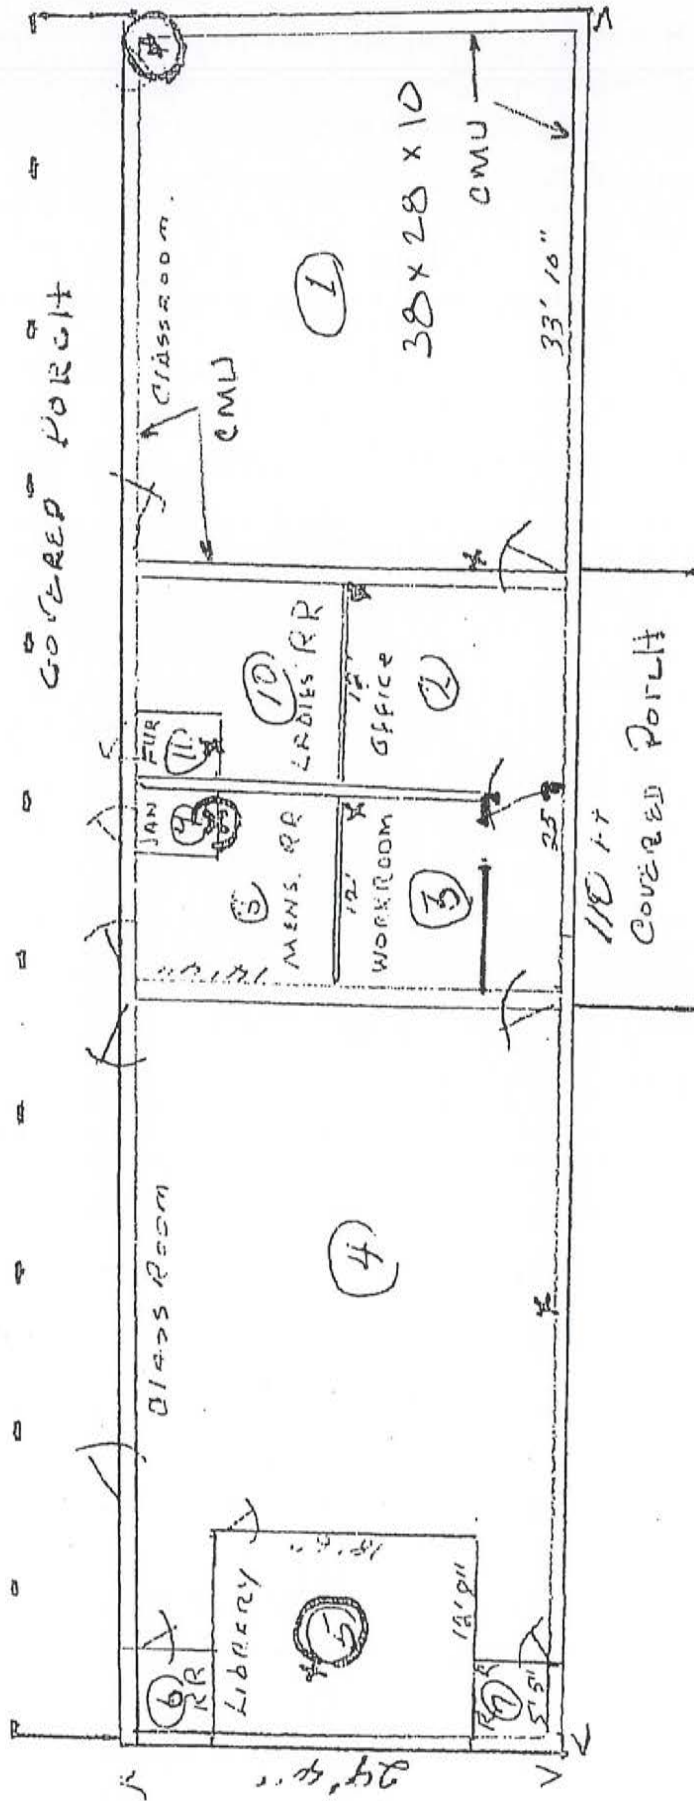
Material: Ceramic tile 2, 1" white
HMR #: 18
Asb: Assumed
Comment: The mortar / grout associated with system is suspect.
